POST-FLIGHT INVESTIGATION PROGRAMMES OF RECENTLY RETRIEVED
SOLAR GENERATORS

Lothar Gerlach
European Space Agency—ESTEC (XPG)
Noordwijk, The Netherlands

Abstract

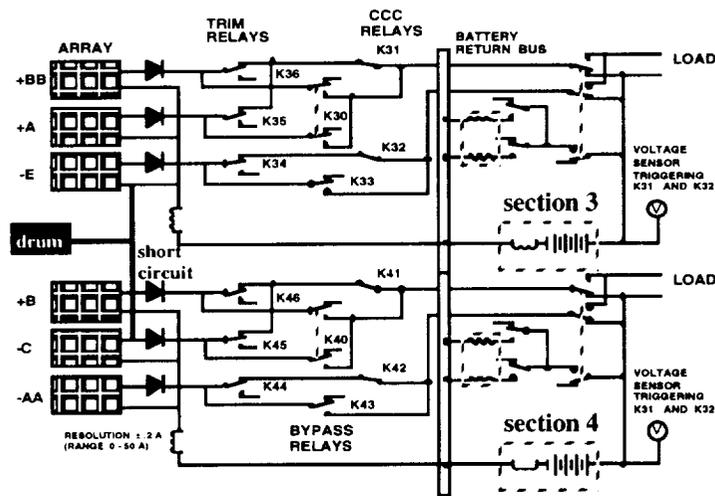
Having reviewed the anomaly history of both solar array wings together with the recent in-flight data it was concluded that there was a short from the positive rail of SPA-C (SA section 4) to the return rail of SPA-E (SA section 3) and a short from the newly formed SPA -C/E circuit to structure (fig. 15).

The above shorts are theoretically possible at several locations, due to the physical layout of the blankets. This is limited to SPA-C and the IBA of the upper blanket (-wing). Other theoretically possible failure locations (PCU, diode box, harness) were investigated but the in-flight data was never in agreement with possible failure scenarii.

Figure 15: STSA-1 Section 3 and 4 logic with short circuits indicated

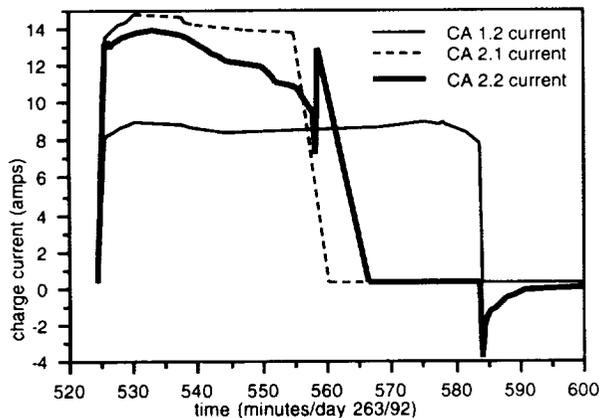
On day 263 of 1992 it was observed that during the first minutes after entering eclipse the current sensor of section 2.2 indicated a current from the battery to the solar array (no blocking diodes were put between the SA and battery circuits). Figure 17 shows the actual current profile. The current profile with its obvious sensitivity to temperature changes is typical for a short circuit. An evaluation of the in-orbit data indicated that the short is present at about half the string length of a solar cell string (40% branch of section 2.2) with three solar cells in parallel and 124 cells in series.

Figure 17: Charge current profile at time short circuit

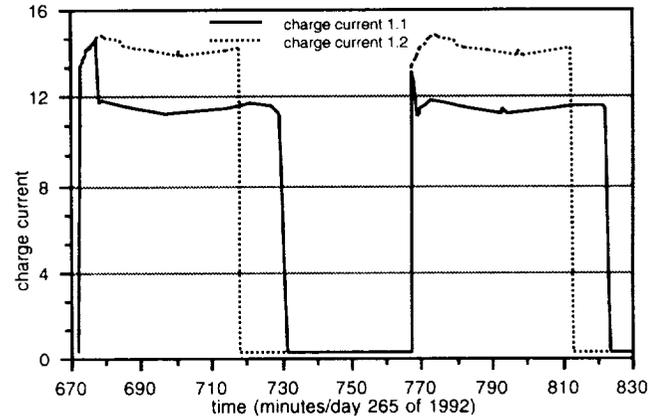
Figure 18: Orbit with first open circuit failure

Between 21 Sept. 92 (day 265) up to the end of the mission a certain number of open circuits were observed, first in the charge array sections and later also in the load array. From 21 Sep. 92 onwards sudden drops of ≈ 1.5 and ≈ 3 amps were observed in the charge current profile (1.5 amps corresponds to the current generated by one solar cell charge string). In the beginning wing 1 charge sections were affected and only towards the end of mission wing 2 solar cell strings started to fail. In some cases the loss was immediate, in other cases the string toggled before the single or double string was lost. In all cases the first drop in current generation was within the first three minutes after entering orbit day. A typical sample of recorded current profiles, showing an open circuit failure is provided in figures 18. The cumulative charge array power loss during the mission is given in figure 21.

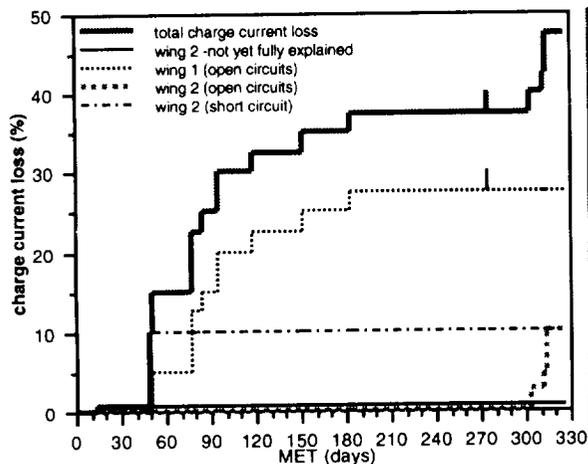
Figure 21: Cumulative charge array power loss during the mission

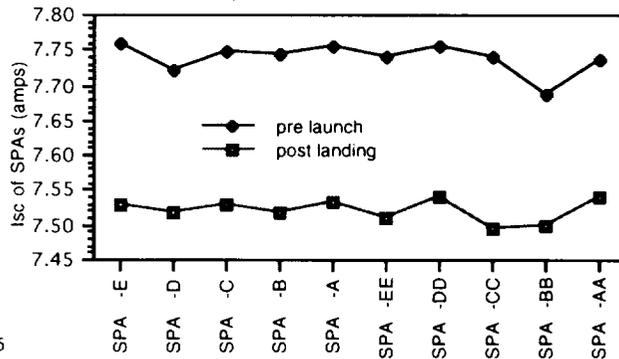
For HST a LAPSS (flash-test) was performed on the integrated solar array blankets. The results are shown in figures 24 to 26 together with the pre-flight data. The Pmax data were intentionally left out because at this test level they are not suitable for power degradation studies. There are too many unknowns due to blanket wiring and harness. The results for the currents are very homogeneous. There are insignificant small variations between the SPAs. The measured degradation for the two operation points (short circuit and at 34 volts) is 3%. This is including all cell damages (particle impacts etc.). The results are as expected, but not in line with the worst case predictions. The worst case relative degradation outlines 10% for these operation points.

Figure 24. Short-circuit current comparison

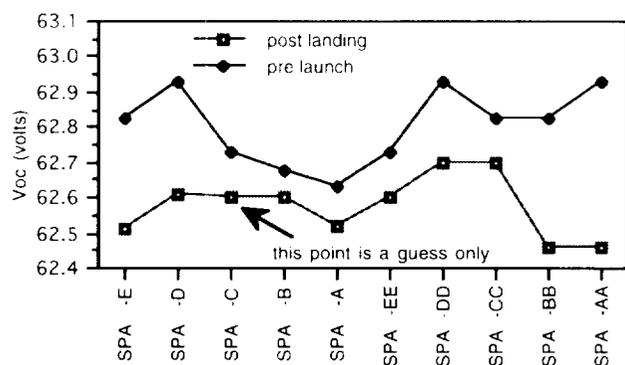
For the open circuit voltages the degradation is smaller than expected. It varies between 0.2% and 0.7% (fig. 25, due to the short in SPA -C no measurement available for SPA -C).

Figure 25. Open-circuit voltage comparison

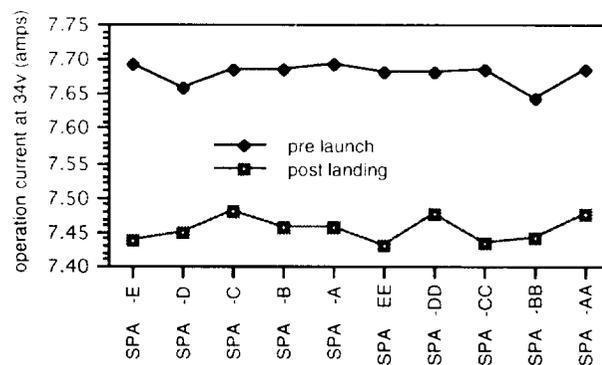
Figure 26. Operation (34v) current comparison

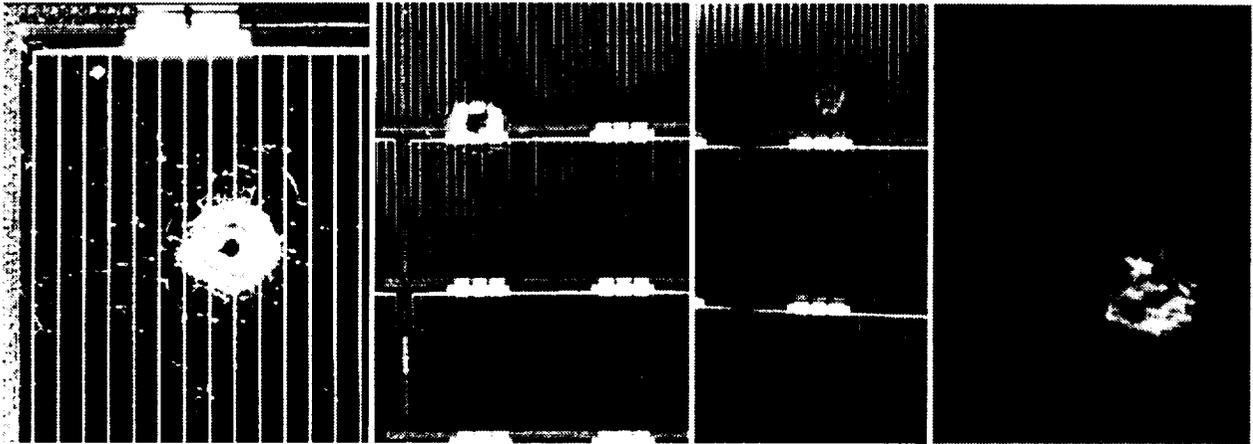
Figure 27. Typical particle impacts

Left: Largest impact feature on EURECA-SA (solar-cell grid finger spacing for all cells = 1.2 mm)

Until now, there is no evidence that any meteoroid or debris impact has caused any of the observed failures. Some of the particles hitting the solar cells have damaged locally the silicon, but the resulting effect is that the chipped off portion or broken portion of the cell simply does not contribute anymore to the power generation. Power measurements on wing level indicate that the remaining cell area functions normally.
